Heavy Ion SEE Test Report for the Micron 4Gbit NAND Flash Memory for MMS

Test Date: 3-4 Nov 2008

Report Date: 27 Jan 2009

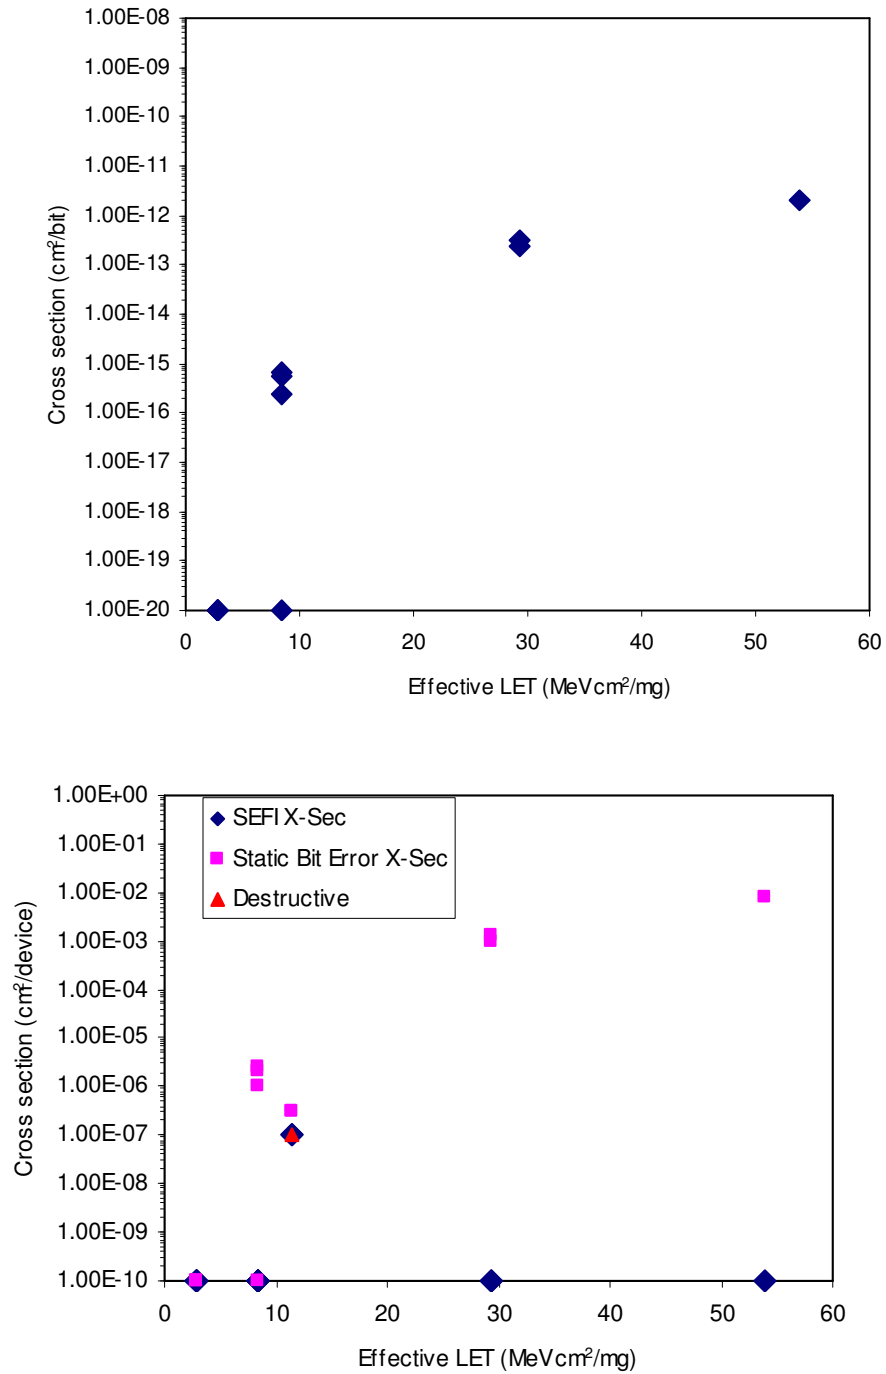
Fig. 4. Results in static test mode: (a) SEU results; (b) SEU results and SEFI results on the same scale.

During testing, the DUTs were irradiated with the ions indicated in Table I. The DUT was oriented normal to the incident beam, except as noted. The errors observed in static SEU testing are shown in Fig. 4a, with no bias applied. In Fig. 4a, the vertical axis is in units of cm^2/bit , as is commonly done for SEU testing. The same data is shown in Fig. 4b, with the vertical axis in units of $\text{cm}^2/\text{device}$, so that SEFI results can be plotted on the same scale.

Even for the static unbiased case, bit errors and two SEFIs with one destructive failure were observed. The most common SEFI mode, generally, was a Block error. One of the static unbiased SEFIs was a block error, where an entire block was lost, presumably from the effects of a single ion. It is likely that Page/Block errors arise due to upsets in configuration registers in the memory array. The other SEFI was different, affecting some bits in every block in the memory. The destructive failure was the loss of the erase function, probably due to damage to the charge pump, which was surprising only because the charge pump was unbiased. The exposures that produced the SEFIs and the destructive failure were at 45 degrees, because we were trying to determine the worst case angle and the angular dependence of the effects. (In Fig 4b, the angular shots are plotted at $\text{LET}=11.4$, nominal $\text{LET}/\cos \theta$.) However, we did not have enough parts to do most of the testing under conditions that would cause catastrophic failure. Therefore, we decided to concentrate on getting normal incidence data first, since there had not been any catastrophic failures on several normal incidence exposures. We intended to return to the angular dependence later, but ran out of beam time before that could be completed. We believe the probability of errors in the control circuits is increased at high angles because more charge is generated close to the surface and over a wider area, and, therefore, closer to multiple active device regions. That is, charge sharing between multiple sensitive nodes is increased, compared to an exposure at normal incidence. Because the DUT was not actively exercised during the static exposures, we could not determine exactly when a page/block error occurred, so cross sections are approximate for these error modes.

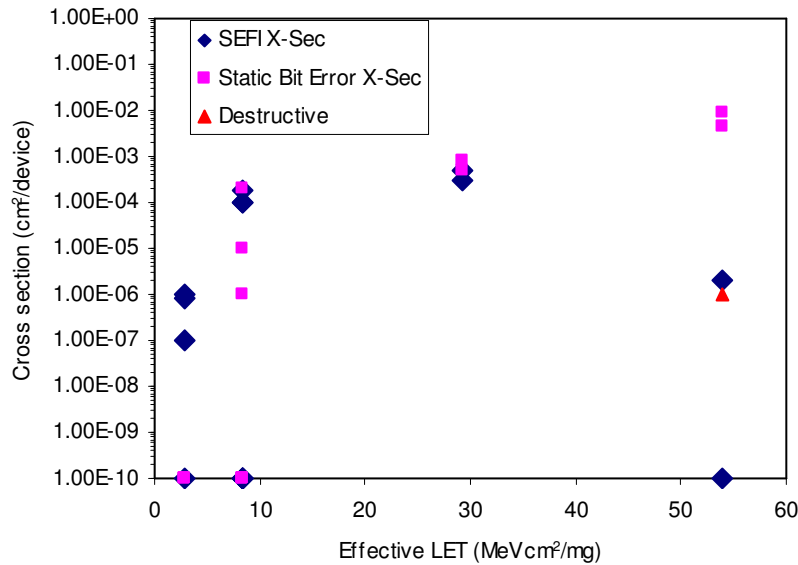
Fig. 5. Results for static mode, with bias applied.

The results for static mode with bias applied are shown in Fig. 5. The SEFI cross section is equal or greater than the bit error cross section at all but the highest LET. These SEFIs are mostly block errors, where every bit in a 128Kx8 block is read as a zero (compared to a checkerboard that was actually stored). After the beam is turned off, multiple reads produce the same result, until power is cycled. After cycling power, the DUT can be read normally—the stored pattern is still stored, except for perhaps the occasional single bit error. Thus, there is a relatively simple way to recover from SEFIs in these NAND flash chips, because the nonvolatile technology is designed to retain information with the power turned off. The recovery method

described here also works in all the other test modes, although the SEFI rate is initially higher in some of the dynamic test modes. We note that the single bit error cross sections in Fig. 5 are very similar to those in Fig. 4, although the SEFI rate is higher with bias applied. We also note that there are no results in Fig. 5 for angles other than normal incidence, which is not the case in Fig. 4. Otherwise, the difference in SEFI rates would be even greater. The destructive failure was a latchup, even though the test was not done at elevated temperature or voltage. After cycling power, the erase function did not work.

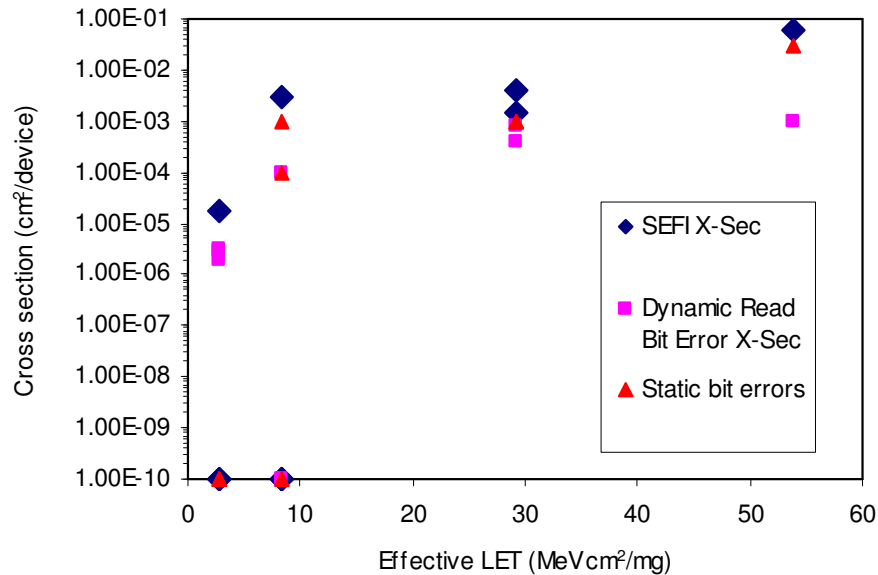
Fig. 6. Results for Dynamic Read mode.

For the Dynamic Read condition, the parts showed exhibited transient read errors in addition to the bit and Block errors, and other SEFIs, which are plotted in Fig. 6. In this mode, the DUT reads continuously with the beam on. The SEFI cross sections in Fig. 6 are roughly two orders of magnitude larger than the static mode results in Fig. 5. This result is not surprising—the more functions the control logic performs with the beam on, the more likely it is to have major errors. The static bit errors are those remaining after power is cycled, as before, and also as they will be for the remaining test modes. Transient bit errors, again, will be those that reset when power is cycled, if not before. Some transient errors are bits read erroneously, due to noise in the read circuit, which will be read correctly on the next pass through the memory. Others will be repeated on subsequent reads, but they are corrected by cycling power.

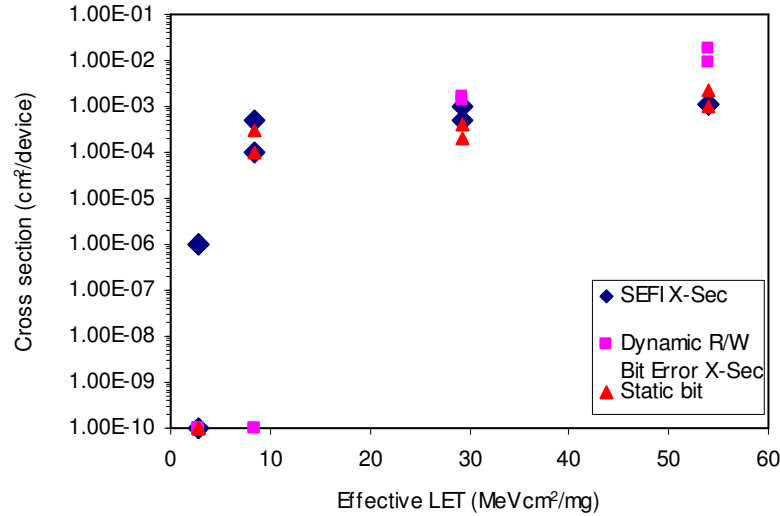
Fig. 7. Results for Dynamic Read/Wright mode.

Results of the dynamic R/W tests are shown in Fig. 7. Generally these results are unremarkable, because the usual zero-to-one errors are rewritten as they occur. For this reason, there are fewer errors indicated than in Fig. 6, although the difference is not large. The main reason for including this test was the expectation that the high voltage write operation would contribute to more errors in the control circuits, but this appears not to have happened, at least not on a large scale. Probably, this is because the write operation is performed only when a zero-to-one error is detected. For this circuit, there are relatively few such errors, so the write circuit duty cycle is a very small number. Where a static cross section is given, it is based on the number of errors detected after the exposure and resetting of the DUT, as before. The transient cross section is based on errors detected during the exposure. But some of the transient errors are probably really static bit errors that were rewritten during the test.

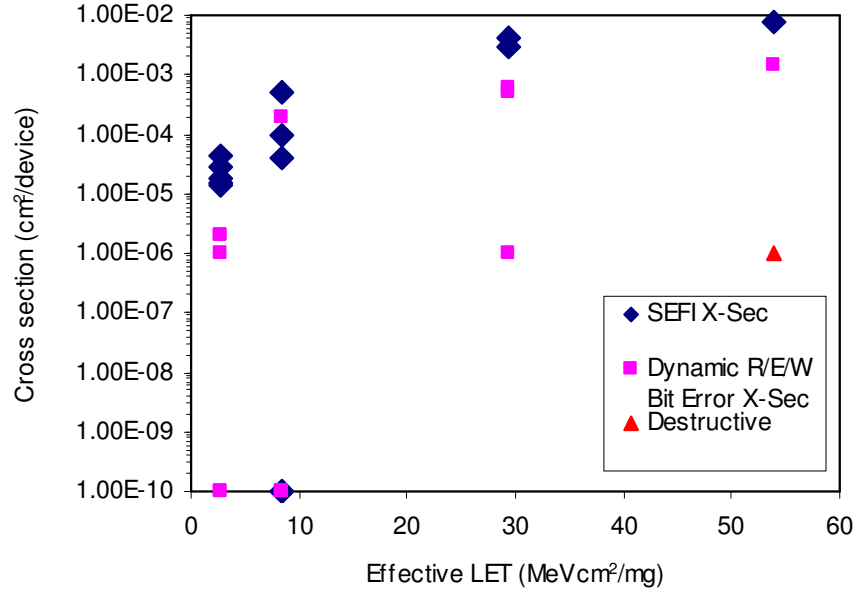
Fig. 8. Dynamic Read/Erase/Write results.

Results for the dynamic R/E/W tests are shown in Fig. 8, to the extent that they can be determined. For this condition, there were many more SEFIs than in the R/W (without erase) mode, which is probably due to the fact that every block is erased and rewritten on every cycle, so that the duty cycle for high voltage operations is much higher. As a practical matter, there are many page and block errors, which usually appear to be independent, on almost every shot with LET at or above 8.4 (Ar). With many large chunks of the memory completely knocked out, it becomes difficult to determine static or transient errors affecting only single bits. The one destructive failure was a latchup, with current jumping to about 80 mA almost as soon as the beam was turned on and staying there until power was cycled, about two minutes later. Afterwards, the DUT could be read normally, but the erase function had been destroyed. This exposure was performed at $T=70^{\circ}\text{C}$, and $V_{dd}=3.6\text{ V}$.
